MARYLAND HISTORICAL TRUST NR Eligible: yes **DETERMINATION OF ELIGIBILITY FORM** no Property Name: H. T. Deaver Farmstead Inventory Number: F-2-68 Address: 511B Jefferson Pike City: Knoxville Zip Code: 21758 County: Frederick USGS Topographic Map: Harper's Ferry Owner: Is the property being evaluated a district? yes Tax Parcel Number: _____Tax Map Number: _____ Tax Account ID Number: _____ Project: Daugherty Property Cell Tower Agency: FCC Site visit by MHT Staff: yes Name: Is the property located within a historic district? _____yes _X_ no If the property is within a district District Inventory Number: NR-listed district yes Eligible district yes District Name: Preparer's Recommendation: Contributing resource yes no Non-contributing but eligible in another context If the property is not within a district (or the property is a district) Eligible X yes ____no Preparer's Recommendation: ___A___B_X_C___D Considerations: ____A__B__C__D_E F G None Criteria: Documentation on the property/district is presented in: Maryland Historical Trust Survey Form Description of Property and Eligibility Determination: (Use continuation sheet if necessary and attach map and photo) Located along a rural

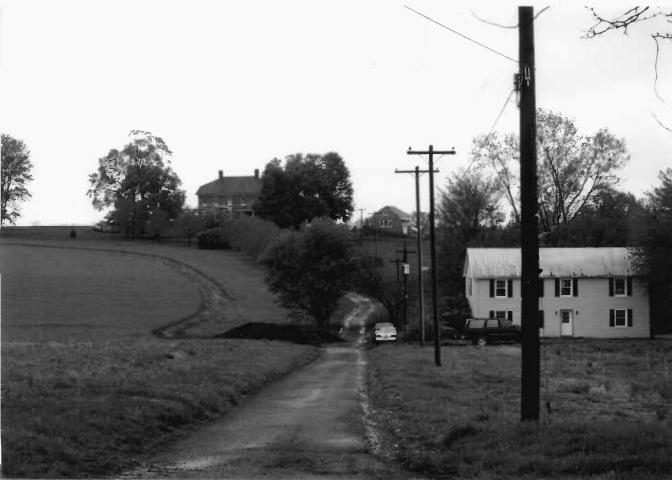
1067

View toward farm complex facing south,

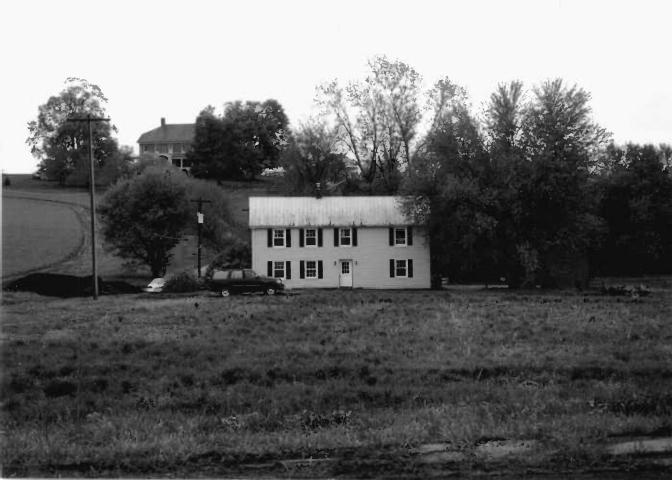
2 % 7

tera t house front elevation

facing south

Tenant house: The two-story tenant house was apparently built in two sections and may contain log structure in the original part. The house is located south of the entrance drive with the main elevation facing west. The original section may date from about 1840-1850 and has three bays with a center entrance. A one-bay extension on the south gable end may date from the last quarter of the 19th century. The exterior is covered with asbestos shingle siding and the roof is standing seam metal with a center chimney. The sash is 6/6. A rear two-story wing extends to the east.

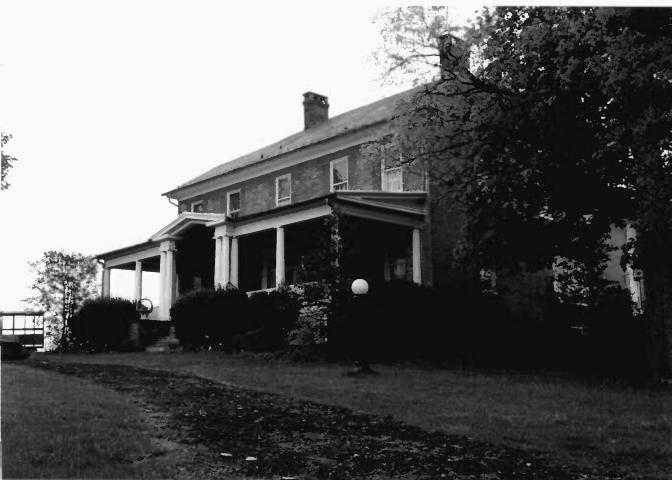
transom and sidelights of the front entrance. The one-story verandah across the front façade appears to be a later Colonial Revival addition. The jerkinhead roof form of the residence is unusual in the area and it is repeated on the springhouse and the carriage house to produce an architecturally cohesive collection of buildings.

mains house front elevation face ent 3 % 7

The main dwelling house was built in 1865 (Scharf, History of Western Maryland, p. 622), replacing an earlier structure, the site of which has not been determined, but may be on approximately the same hilltop location of the present house. The building is two stories in height with five bays and a one-story porch on the main The slate roof is hipped with jerkinhead gable ends. elevation facing northwest. The foundation is stone and the brick bond is stretcher on the main elevation and 6:1 or 7:1 on the side and rear elevations. The brick was painted, but is now The center entrance is approached through a central projecting pavilion weathered. in the porch. The porch has Tuscan columns. The doorway has a replacement doc surrounded by a transom and sidelights. The windows are 6/9 on the first story with the sills at floor level. The arches are gauged brick. The second story sash is 6/6. The outlines of shutters are visible on the brick surface. The double chimneys are centrally located. The side elevations have two bays. On the south elevation, the southeast bay has an enlarged opening with a three-part window. On the north elevation, a third bay containing a hooded entry porch is located near the northeast corner. The rear ell is two stories in height and has an added sun room, probably an early 20th century feature, on the east end of the brick section. On the east elevation of the main part of the building is a two-story porch, the second story of which has been enclosed with a series of casement windows in the style of early 20th century sleeping porches. French doors on the first story open on the lower level of the porch. The interior was inaccessible for this survey.

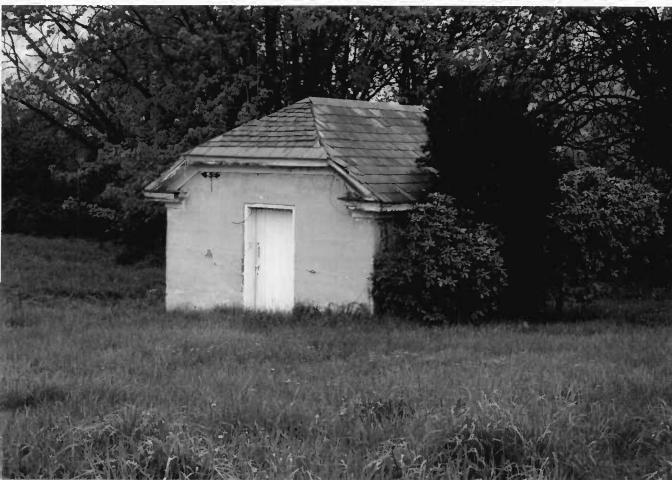
4 4 7

spring house

Springhouse: The stone springhouse is located near the split in the entrance drive which leads to the main house and to the agricultural group. It is stuccoed, with a jerkinhead slate roof similar to the main house roof. An extension of the roof shelters the door on the northeast elevation. The sides have two window bays each. It probably dates from about 1865.

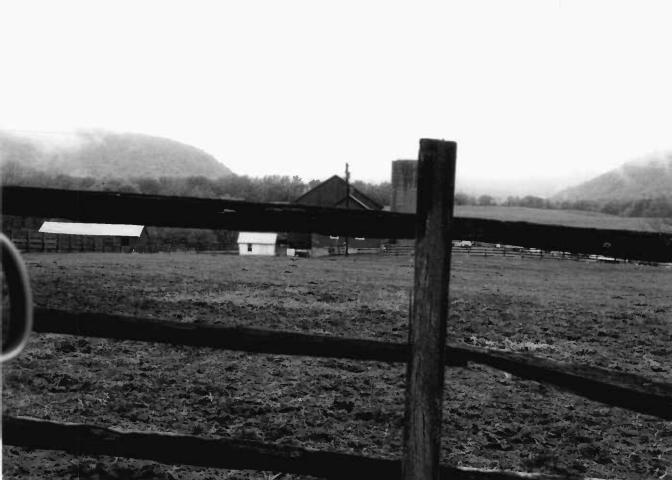
607

H. T. Dealer Farmstead F-2-68 511B Jefferson Pike Knoxine MD FREDERICE CE. I. photogram Kristie Latire, 4/26/08 (E) (0+0) Z 61-Z-N N N **(Z 190 LICK ATTOMS HARLING TO barn facing west

Bank barn: The frame bank barn probably dates from about 1865, but it was not accessible for close inspection. Two sections indicate that an extension was made probably in the early 20th century. It has a standing seam and composition roof.

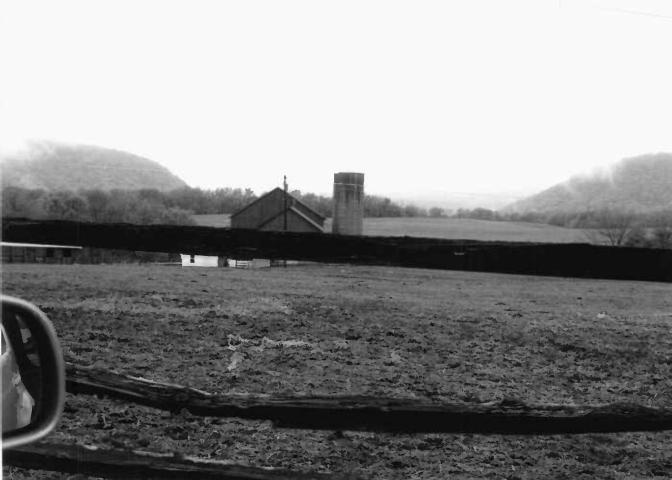
7 0 7

barn facing west
